FLOOD PLAIN MANAGEMENT STUDY

TOCCOA AND EASTANOLLEE CREEKS

STEPHENS COUNTY, GEORGIA

DECEMBER 1981

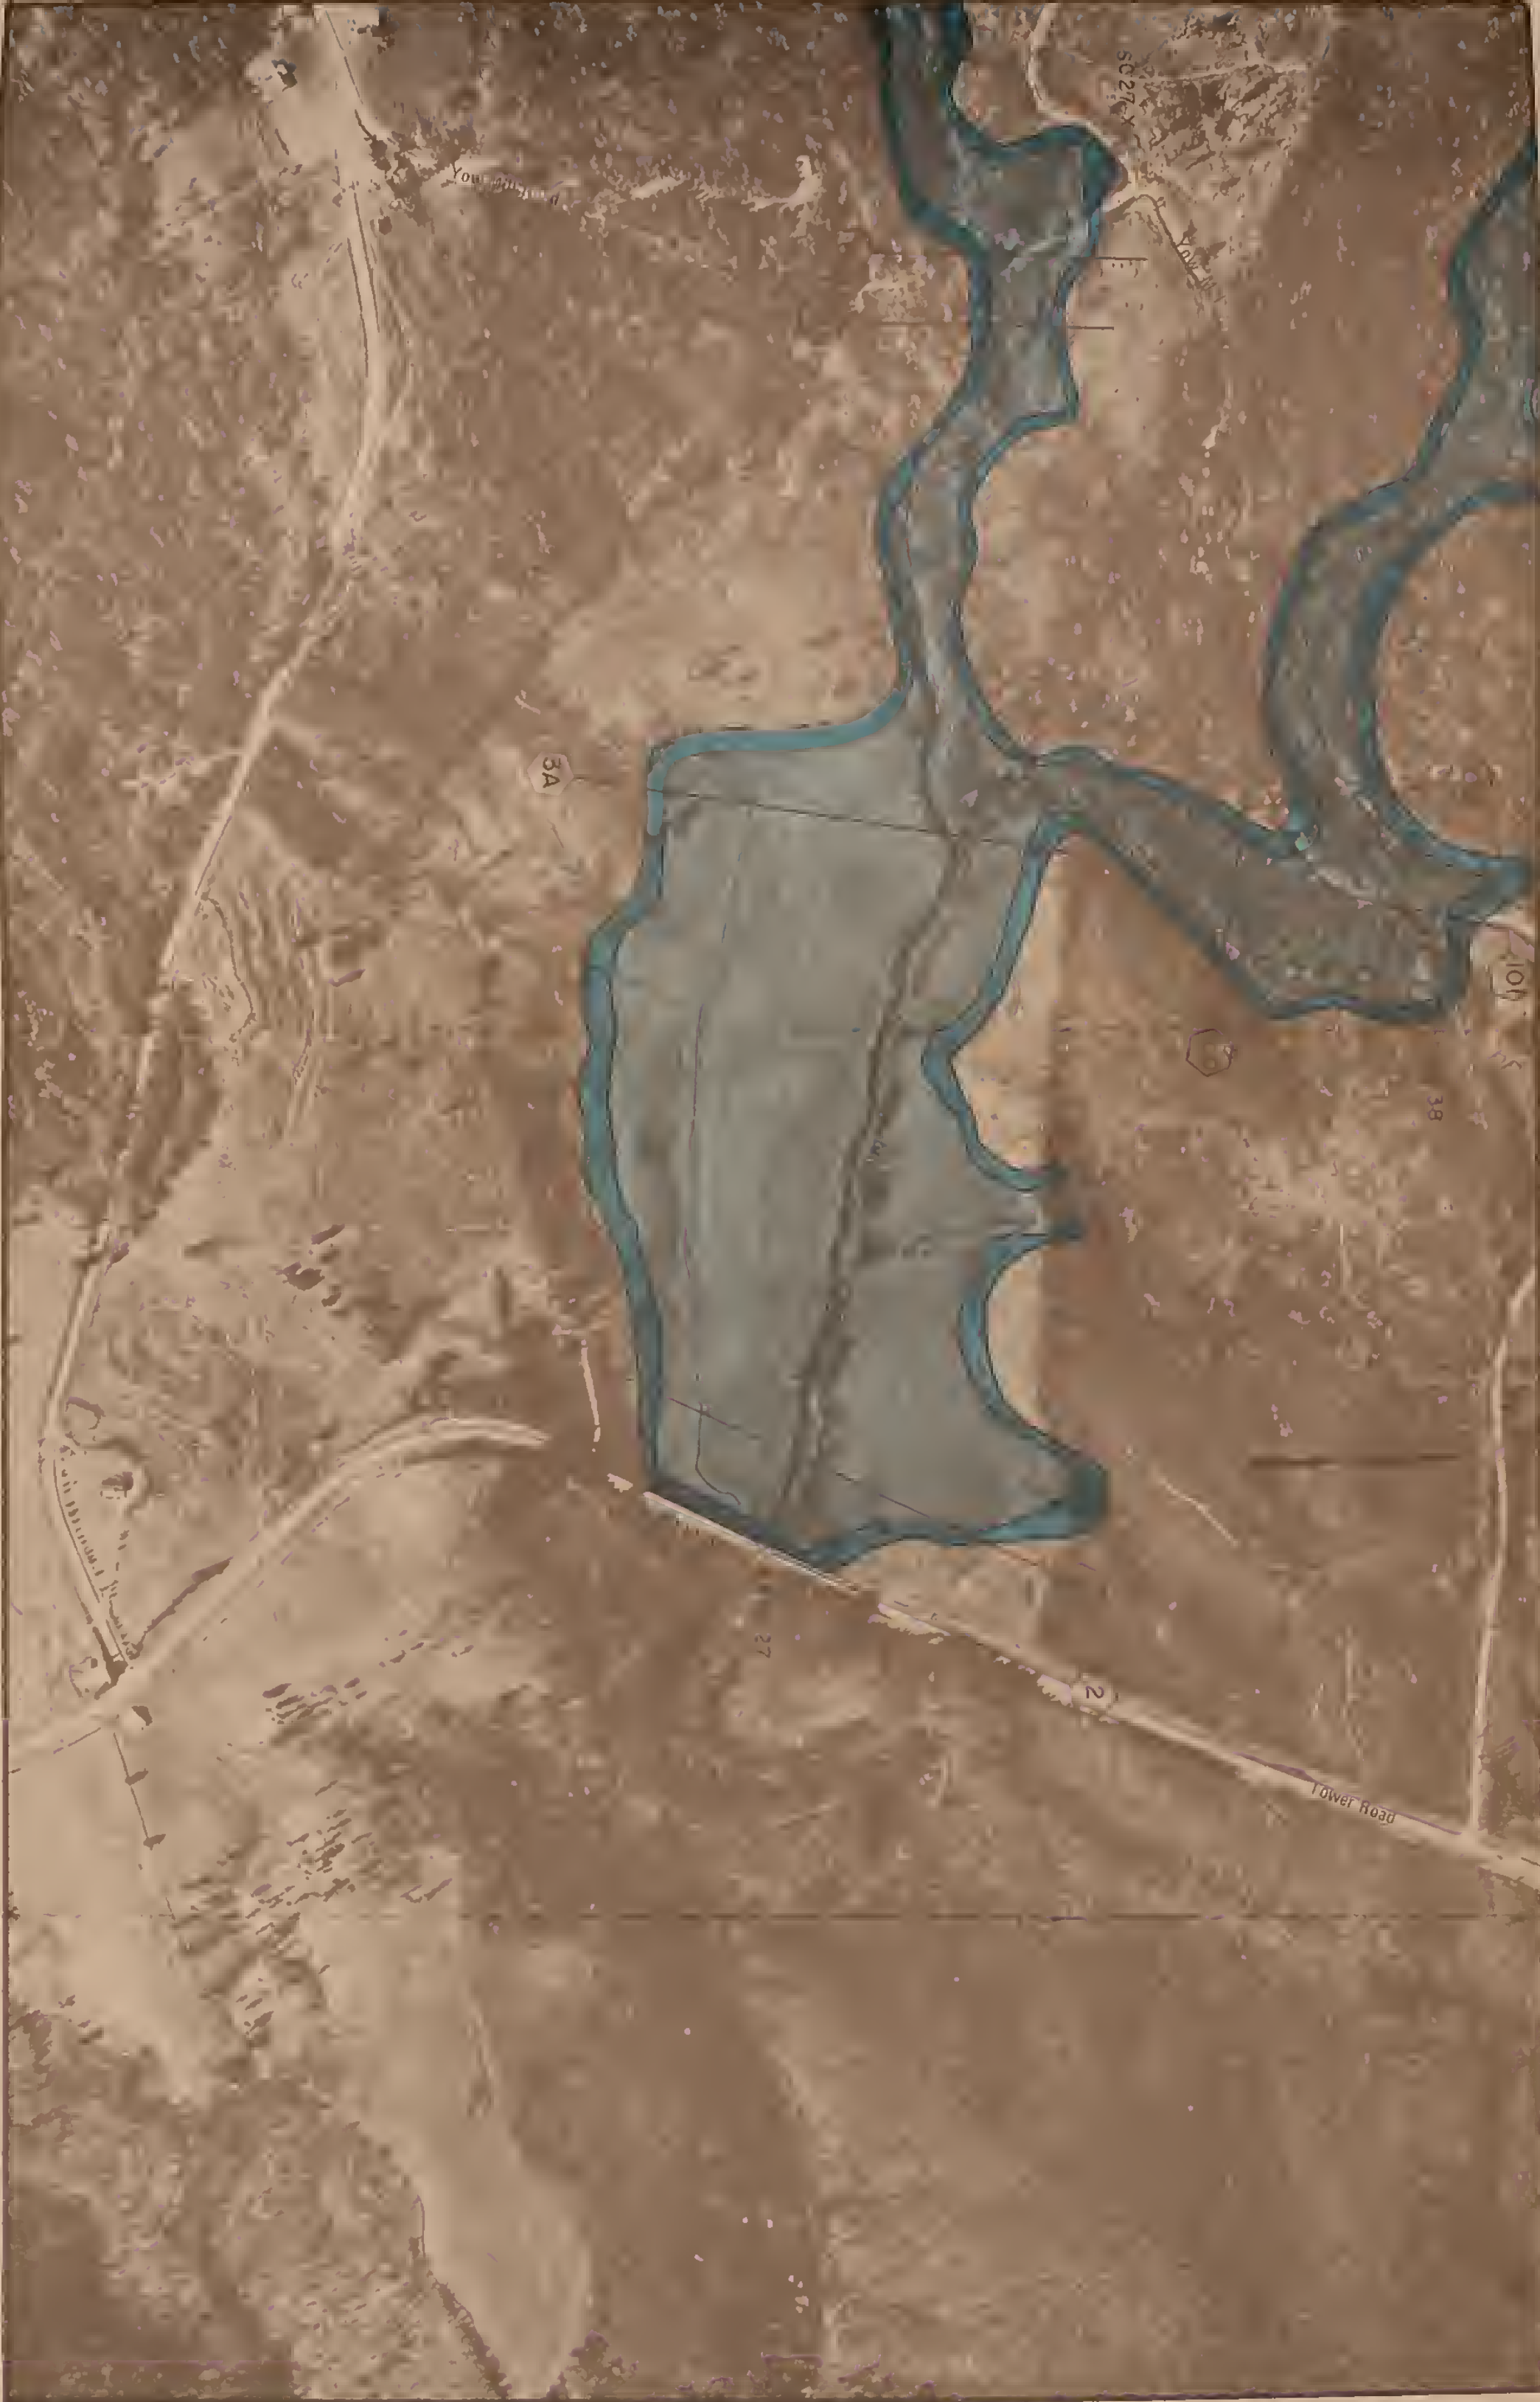
EASTANOLLEE CREEK

Flood hazard areas are shown on the photomaps presented in this report. Photographs used for these maps were made in December 1978. The photomaps show the 100-year and 500-year flood hazard areas and the locations of the surveyed cross sections. Flood hazard areas for various frequency floods are given in Table 2. This table reflects current land use.

FLOOD HAZARD AREA

The on-ground mean sea level (MSL) elevation of the site should be determined by an acceptable survey procedure. Elevation reference marks (bench marks) are shown on the photomaps and are described in Appendix E.

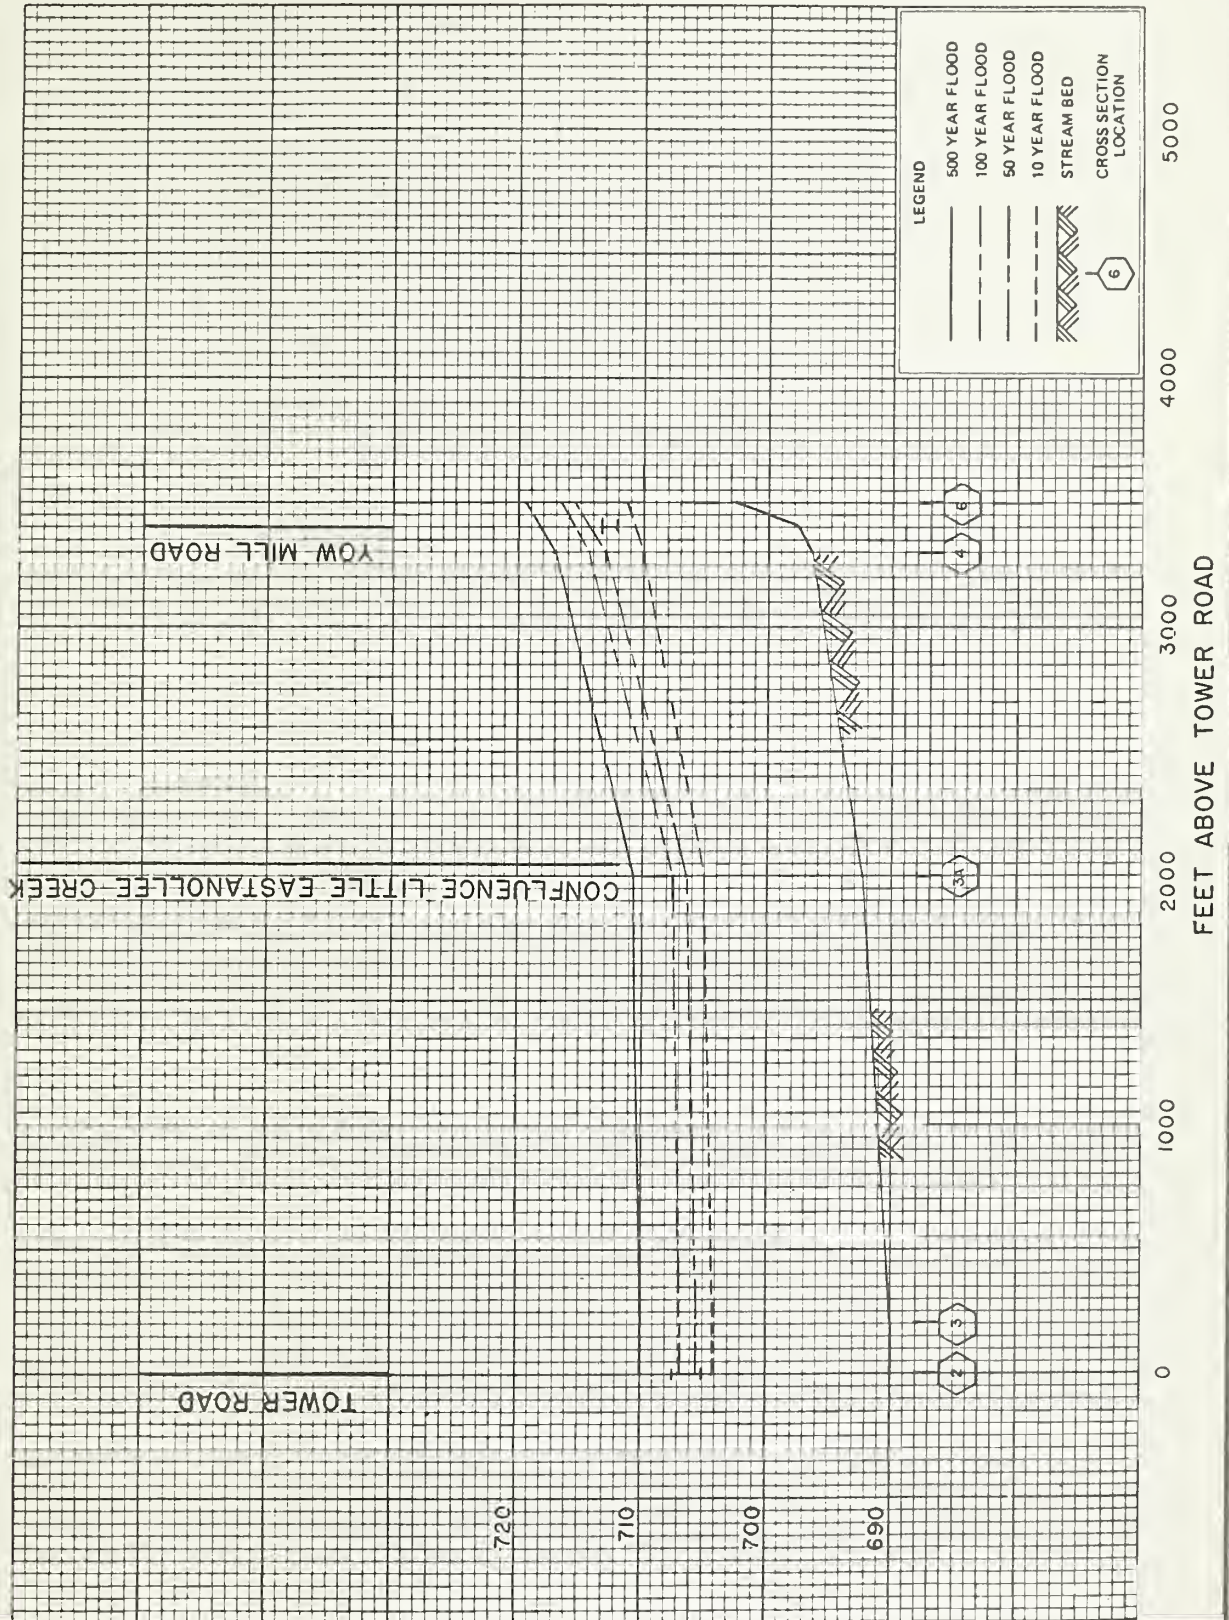
EASTANOLLEE CREEK

Flood profiles for the 10-year, 50-year, 100-year, and 500-year floods are presented in Appendix A. Also shown are the locations of cross sections and road crossings.

FLOOD PROFILES

1. Locate the site on the appropriate photomap sheet.
2. Scale the distance from the site to the nearest cross section.
3. Locate the cross section on the appropriate flood profile sheet (Appendix A); then plot the site the appropriate distance from the cross section. Flood elevations at the site can now be read from the flood profiles.
